AIRCRAFT ACCIDENT REPORT AND EXECUTIVE SUMMARY

Reference:	CA18/2/3/9722	
Aircraft Registration	ZS-BRV	Date of Accident	10 July 2018		Time of Accident	1451Z
Type of Aircraft	Convair 340/440		Type of Operation	Private (Part 91)		
Pilot-in-command Licence Type	Validated Australian PPL		Age	65	Licence Valid	Yes
Pilot-in-command Flying Experience	Total Flying Hours		18240.5		Hours on Type	63
Last Point of Departure	Wonderboom Aerodrome (FAWB), Gauteng Province					
Next Point of Intended Landing	Pilanesberg Aerodrome (FAPN), North West Province					
Location of the accident site with reference to easily defined geographical points (GPS readings if possible)						
The accident occurred approximately 1 kilometre east of the N4 highway in Derdepoort industrial area, and approximately 5.78 kilometres to the east of FAWB Aerodrome. Geographical position was determined to be S26°67.031" E028°28.461" at an elevation of approximately 4095 feet above mean sea level (AMSL).

Reference Number : CA18/2/3/9722
Name of Owner/Operator : Rovos Rail
Manufacturer : General Dynamics
Model : Convair 340/440
Nationality : South African
Registration Marks : ZS-BRV
Place : Wonderboom Aerodrome
Date : 10 July

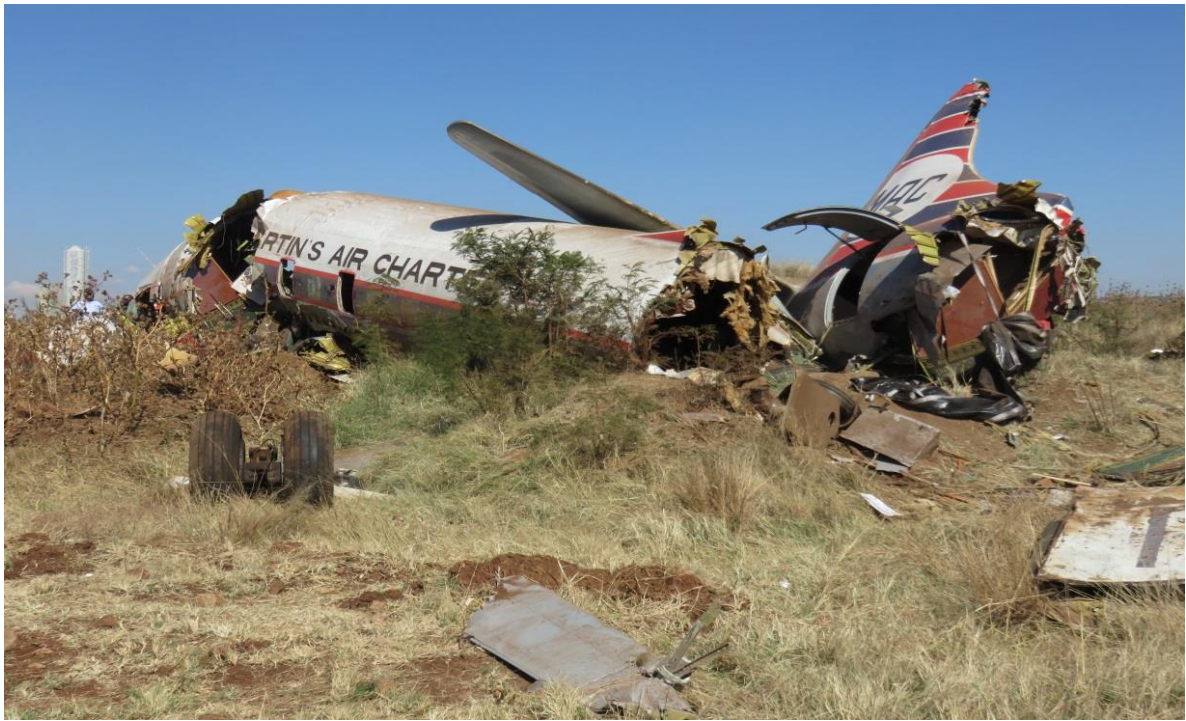
- 1.3.1 The aircraft was destroyed on impact. The in-flight left engine fire caused damage to the left wing and the post-impact fire caused damage to the right main gears and right engine. See Figure 5.

Figure 5: ZS-BRV wreckage as found at the accident site.

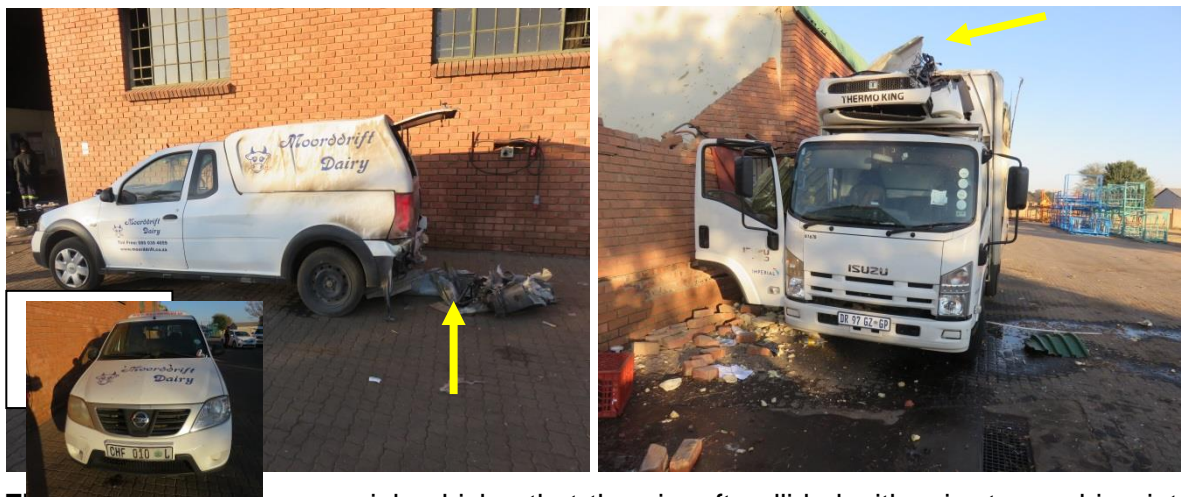
1.4.1 Damage was limited to the power lines that spanned parallel to Sakabuka Street, two commercial vehicles and the factory building. See Figures 6 and 7.

Figures 6/7: Two commercial vehicles that the aircraft collided with prior to crashing into the warehouse. The left image shows pieces of the left wing. The vehicle on the right sustained substantial damage to the freezer.

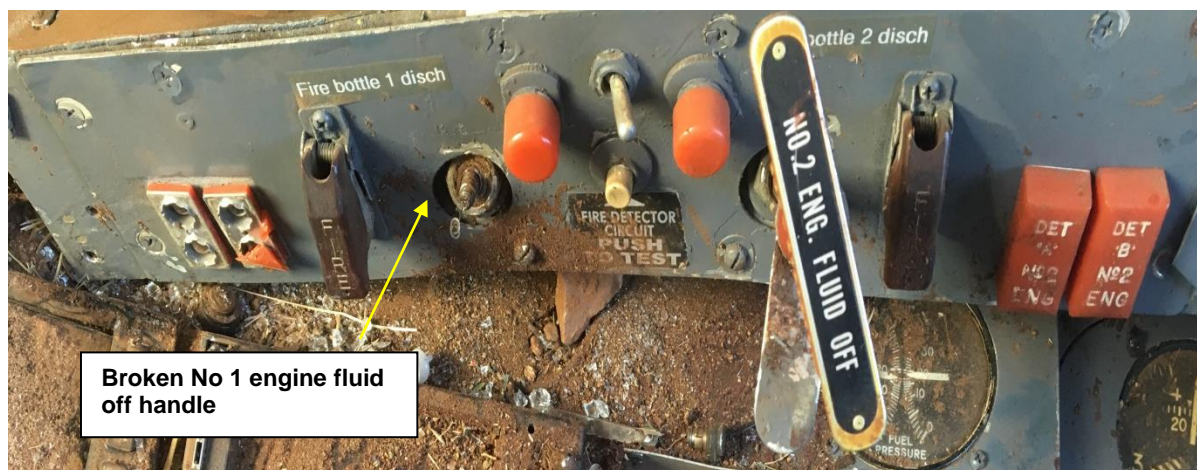
Figure 12: The engine fire extinguisher control panel showing all four unit-detector lights and a broken ‘fluid off’ handle.

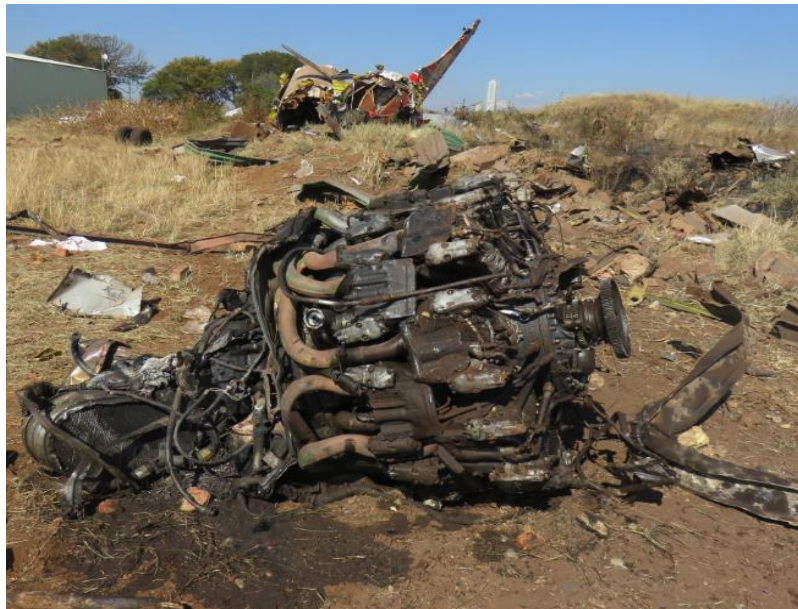
1.12.6 The left-hand engine was located just behind the fuselage at grid station J25. The engine exhibited fire damage signatures near the carburettor. The accessory gearbox had broken off from the housing assembly. The left three-bladed propeller had broken off from the gearbox and was located at grid station K25. The first blade was missing, the second blade had disintegrated from the mid-section, while the third blade was fairly intact. The damage observed on the propeller blades was indicative of damage caused during the running of a low-powered engine. The exhaust tubes were still secured on the centre section of the wing. The exhaust exhibited damage caused by an in-flight fire and had signatures of overheating and discolouration.

Figure 22: The left-hand engine as it came to rest.

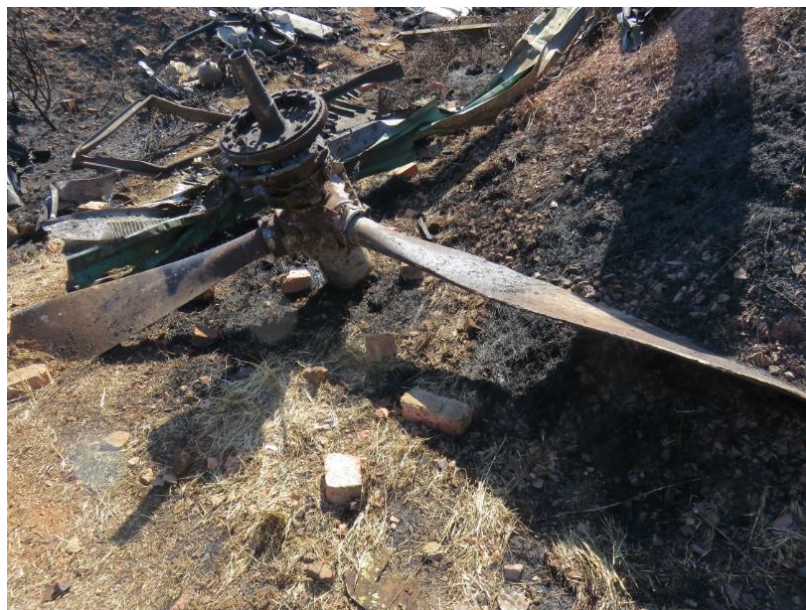
Figure 23: The left-hand propeller.

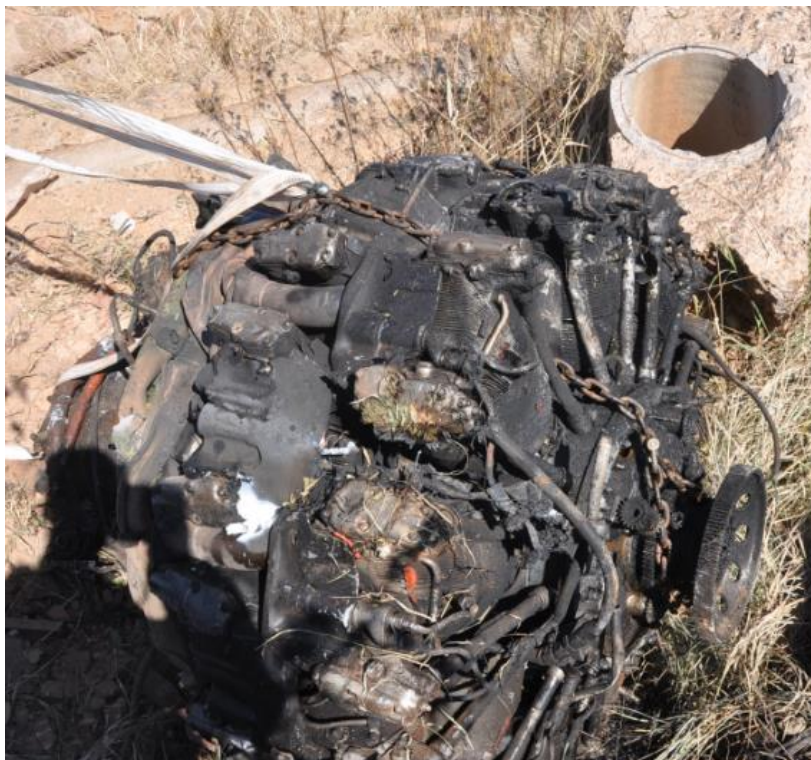
Figure 25: The right-hand engine as it came to rest with black soot indicating exposure to fire.

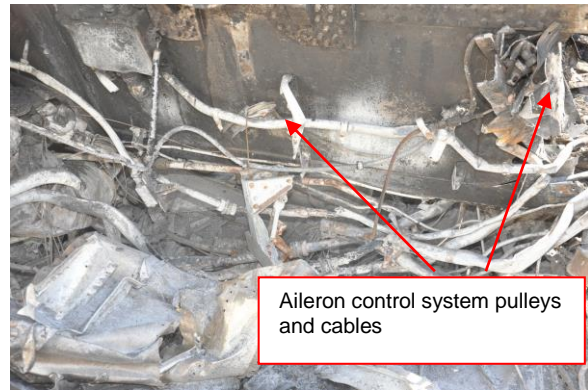
1.12.8 The images below show the damaged rear main spar and the aileron pulley attachment brackets because of the fire that came from the left engine. The pulley attachment brackets were found detached from the spar with slacked cables.

Figure 26/27: Images showing fire damage on the left-wing rear spar and pulley attachment brackets separated from the spar with its pulleys and the cables.

2.5.7 The aircraft made another right turn (base leg) while losing height. It continued in that trajectory and the PF lost aileron control. This occurred due to the weakening of the left-wing rear spar because of fire damage that caused the attachment rivets of the aileron cables to melt, resulting in the cables being slack and, thus, loss of aileron control. The loss of aileron control led to the crew losing control of the aircraft and the aircraft colliding with power lines before impacting the factory building.

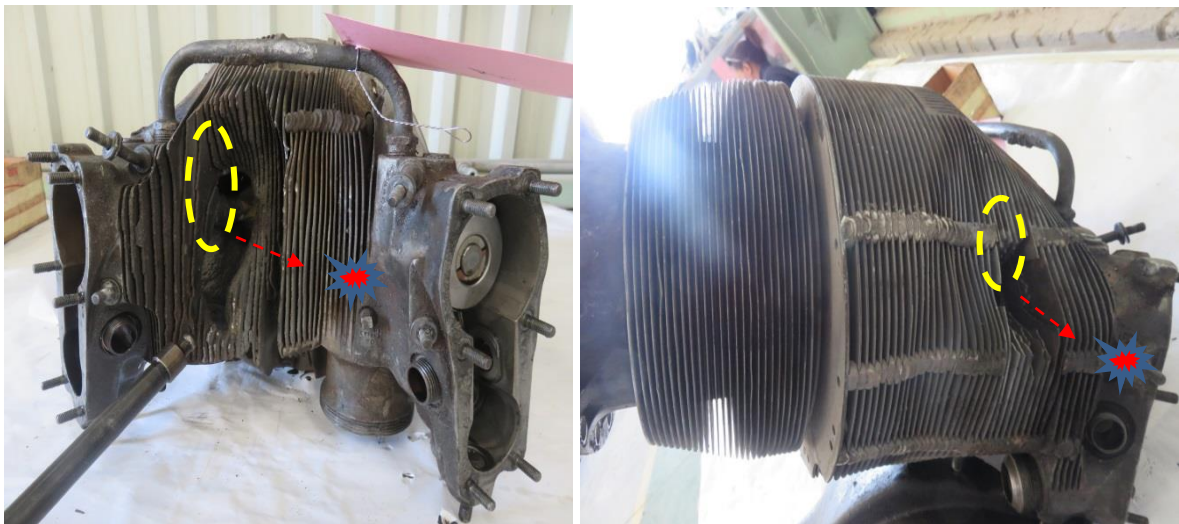
Figures 37/38: Cylinder No 7 showing the hole where the fire escaped.

- 2.5.13 The fire started in the left engine and evidence showed that the No 7 cylinder was the one with the most damage and was the source of the left engine fire. The fire continued burning through a hole on the No 7 cylinder, causing damage to the front wing spar and the left aileron pulley attachment point, melting the attachment rivets. As a result, the left aileron control cables slacked and the aileron deflected slightly up. With the left engine operating at partial power due to damage and failure of cylinder number 7, the aircraft started rolling to the left. The opening of the left engine cowl flaps in-flight increased the intensity of the engine fire and the left roll.

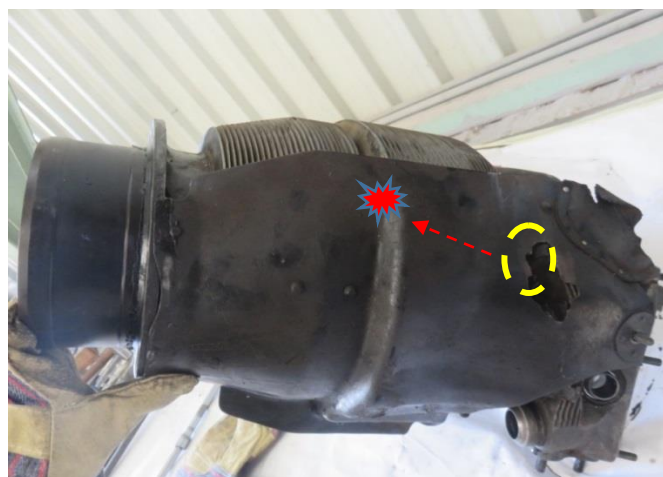
Figure 39: An image of the No 7 cylinder showing the fire damage on the exterior through the cooling fins and the plate.

- 2.5.11 The failure of the No. 7 cylinder exhaust valve led to the cylinder cooling fins overheating, thus, causing the failure of the cylinder housing.
