AIRCRAFT ACCIDENT REPORT AND EXECUTIVE SUMMARY

Reference:	CA18/2/3/9722	
Aircraft Registration	ZS-BRV	Date of Accident	10 July 2018		Time of Accident	1451Z
Type of Aircraft	Convair 340/440		Type of Operation	Private (Part 91)		
Pilot-in-command Licence Type	Validated Australian PPL		Age	65	Licence Valid	Yes
Pilot-in-command Flying Experience	Total Flying Hours		18240.5		Hours on Type	63
Last Point of Departure	Wonderboom Aerodrome (FAWB), Gauteng Province					
Next Point of Intended Landing	Pilanesberg Aerodrome (FAPN), North West Province					
Location of the accident site with reference to easily defined geographical points (GPS readings if possible)						
The accident occurred approximately 1 kilometre east of the N4 highway in Derdepoort industrial area, and approximately 5.78 kilometres to the east of FAWB Aerodrome. Geographical position was determined to be S26°67.031" E028°28.461" at an elevation of approximately 4095 feet above mean sea level (AMSL).

Reference Number : CA18/2/3/9722
Name of Owner/Operator : Rovos Rail
Manufacturer : General Dynamics
Model : Convair 340/440
Nationality : South African
Registration Marks : ZS-BRV
Place : Wonderboom Aerodrome
Date : 10 July

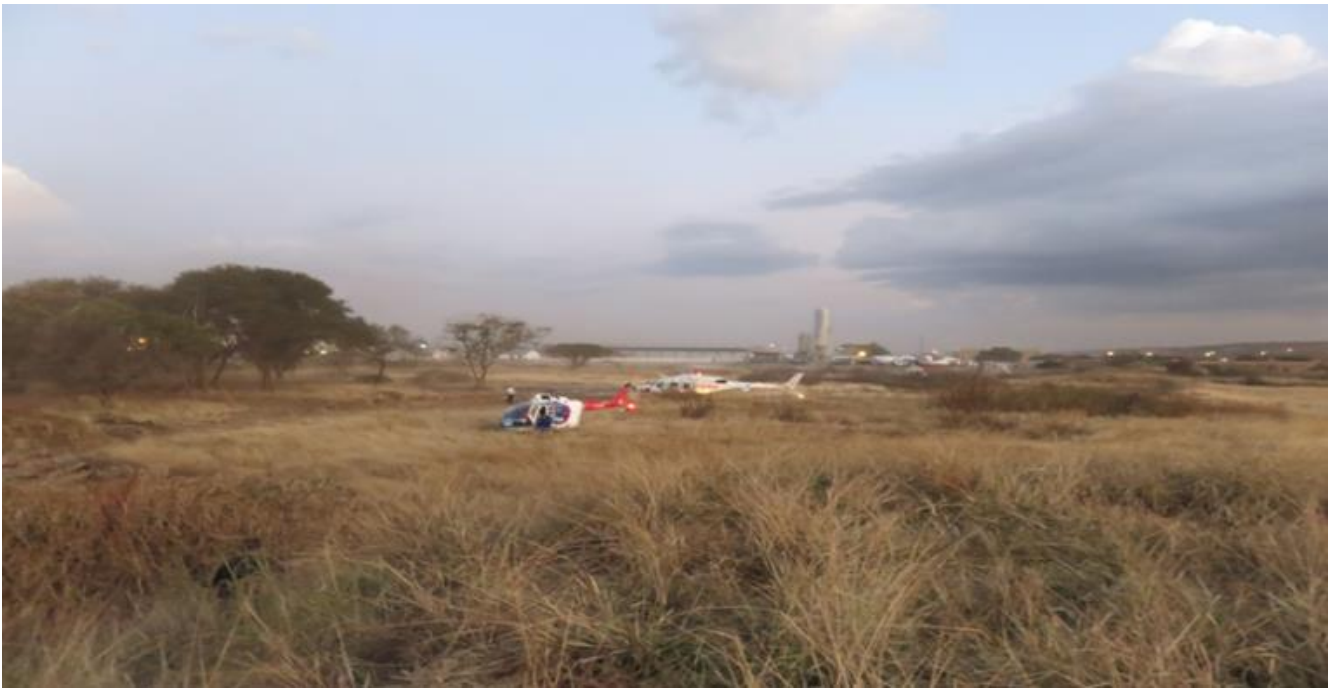
Figure 28: The ER24/Netcare 911 helicopters at the accident site.

1.15.2 The emergency helicopters flew to the area of the accident approximately 30 minutes after the crash. The helicopters airlifted the PF and his wife, as well as the PM to a hospital in Johannesburg. The accident rescue personnel disturbed the cockpit area as they were rescuing the injured crew members, as well as when they were removing the body of the LAME who was fatally injured.

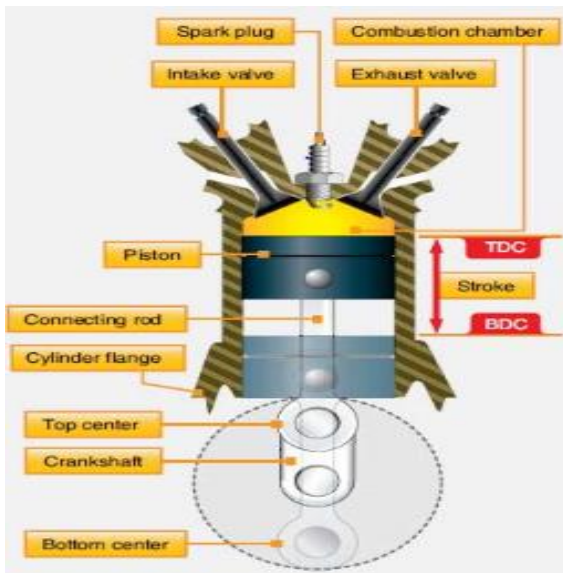
1.16.3 Following the recovery of both engines and propellers from the accident site, the No 1 engine S/N P-37351 was subjected to a borescope inspection procedure. The borescope inspection found that cylinder No 13 had piston damage and carbon build-up on the valves. See images of the piston crown – Figures 29-32.

Figures 33/34: A sketch of components and terminology of engine operation and an image of the No 1 engine's cylinder No 13 piston displaying damaged compression and oil control ring packs and hard carbon on the piston crown.

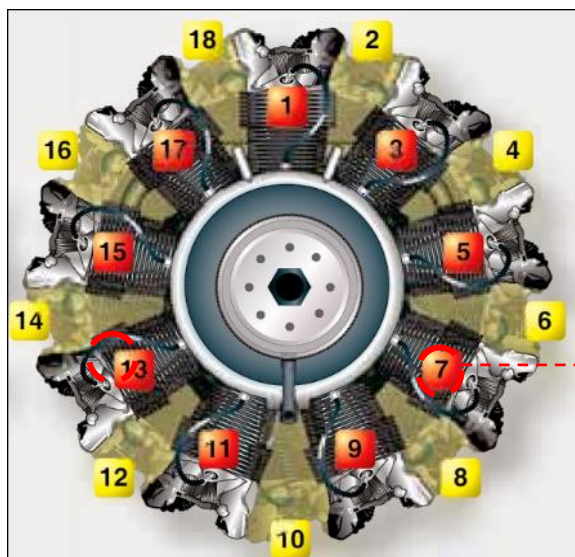
1.16.8 After the removal of the No 7 cylinder, the exhaust valve (P/N: 331107) head was found to be fractured. Further examination indicated that the inlet and the exhaust valves return springs and rocker arms were intact and in good condition. The No 7 cylinder cooling fins/plate (valve housing) had damage on the side wall.

See Figures 35/36/37/38/39 of the images taken during the engine teardown examination showing the damage caused by the fire on the No 7 cylinder.

Figures 35/36: On the left is the 18 double-row, air-cooled Pratt and Whitney R-2800 radial engine and on the right is an image of the No 7 cylinder combustion chamber, showing a fractured exhaust valve head.

1.16.10 The engine No 1 manifold pressure drop, as reported by the crew during the take-off roll, was the result of the No 13 cylinder damaged piston crown, piston rings and fractured No 7 cylinder exhaust valve head which subsequently caused backfiring.
